# Effect of a GPS Anomaly on Different GNSS Receivers

Anne-Laure Vogel, *Sofréavia, France*  
Christophe Macabiau, *ENAC, France*  
Norbert Suard, *CNES, France*

On January 1<sup>st</sup> 2004, a GPS clock failure occurred suddenly onboard the GPS satellite PRN23 at around 18:30 UTC with the signal being transmitted for hours after that. The Unhealthy flag of its navigation message, used by the receivers to discard its measurements from the navigation position computation, was raised a few hours after the occurrence of this event.

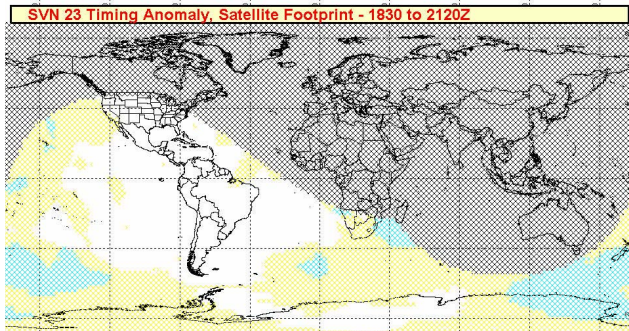
Figure 1: Affected area shown in gray [RD1]

An important anomaly of the GPS system occurred on January 1, 2004, starting at around 18h30 UTC, and affecting time and position estimates on a very wide zone illustrated in figure 1.

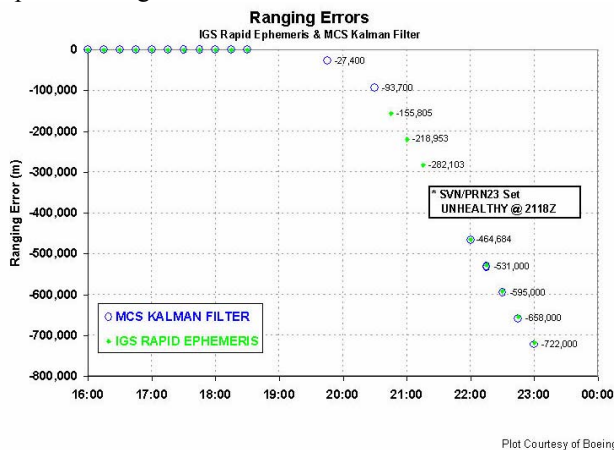
Figure 2: Pseudo-range error on the PRN 23 [RD1]

This anomaly was due to a failure of the atomic clock system on the satellite PRN 23. The satellite PRN 23 was declared unusable at 21h18 UTC through transmission of the corresponding SV Unhealthy flag in its navigation message. This failure induced very important errors on the pseudo-range of the satellite 23 as depicted in figure 2.

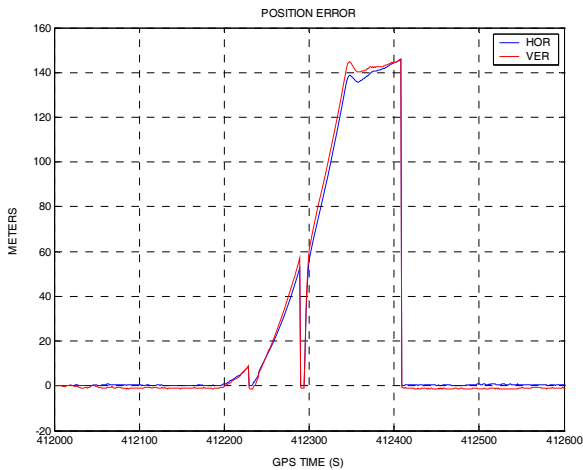
**Figure 3: Horizontal and vertical position error from 18h26min40s to 18h36min40s (GPS time)**

Starting from 18h29min53s (that is to say 412193 sec. in GPS time), we note that the horizontal and vertical position errors increase quickly to 150m as shown on figure 3. These values are in conformity with those observed by CNES [RD 3].

Approximately 200 seconds after the appearance of the incident (GPS time 412409s), the receiver provides positions with horizontal and vertical errors becoming again normal. It seems that the receiver fails to track the satellite 23.

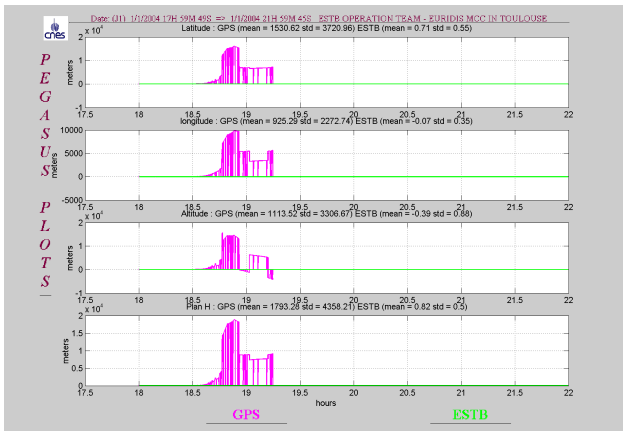
**Figure 4: Latitude, Longitude, Altitude and Horizontal errors from 18h00 to 22h00 UTC**

In this case, as the receiver of the IGN station continued tracking the satellite 23, we observe positioning errors of several km.

At 19h15min UTC, the receiver of the IGN station stopped to deliver PRN 23 measurements and position estimates became correct again. It is also the same phenomenon that occurred for the majority of the permanent GPS reference stations.

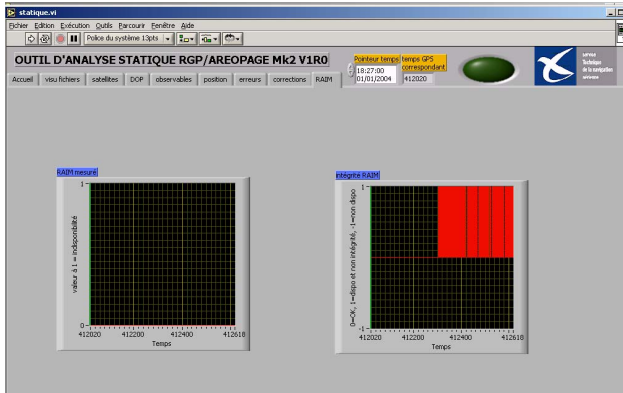
Figure 5: « RAIM » functionality from 18h27 to 18h37 – GPS time

Starting from 18h31min43s (412303s), the flag of RAIM integrity is activated. At this time, the altitude error reached 54 meters and the horizontal error 45 meters (values obtained using the analysis tool).

The RAIM detection criterion which is calculated by AREOPAGE Mk2 and which emulates the RAIM of a standard supplemental TSO C129 receiver, such as necessary for NPA-GPS (LNAV) approaches, detected the failure as soon as the error reached a too large value, 110 seconds after the beginning of the failure in that case.

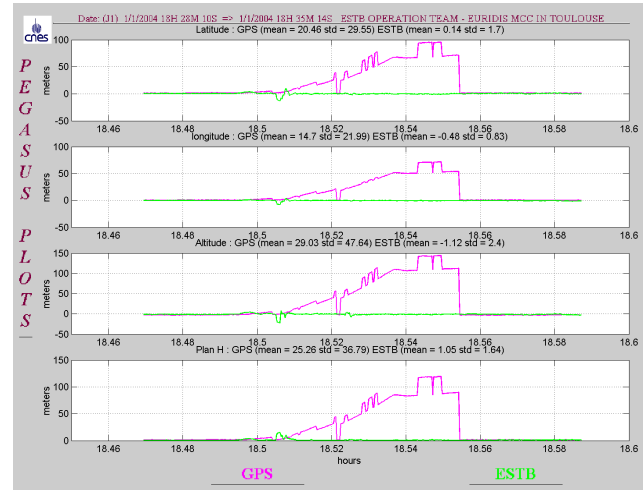
Figure 6: Positions errors (Lat, Lon, V, H) observed with ESTB (green) and GPS only (magenta) functions.

The receivers using ESTB also underwent drifts of position when the failure appeared. These errors reached a maximum of 15m in horizontal and 25m in vertical and only lasted less than 5 seconds, then the PRN23 was excluded in the internal ESTB time reference. These errors are definitely lower than those of standalone GPS receivers. Moreover, the satellite PRN23 was excluded by the ESTB system at 412228s (35 seconds after beginning of the failure).

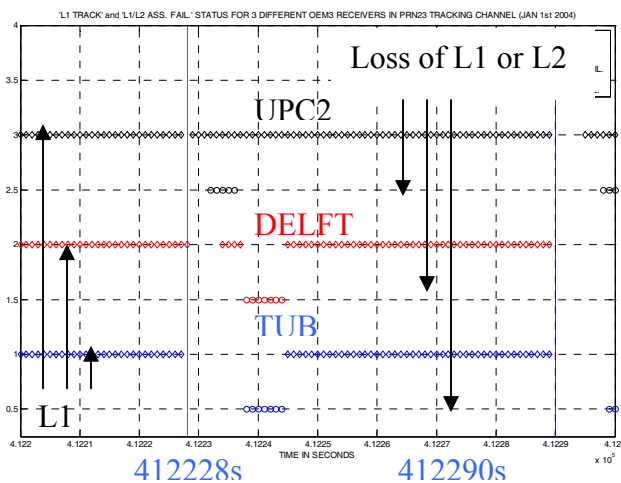
**Figure 7: PRN23 tracking status for 3 different OEM3 receivers (TUB, DELFT, UPC2).**

As we can see in this figure, TUB and UPC2 receivers lose lock at the exact same time, which is 412228s. DELFT receiver loses lock one second later, at 412229s. Then, UPC2 receiver re-locks on the signal the second after. DELFT receiver regains lock 5 seconds later at 412234s, to lose lock again at 412238s for 6 seconds. TUB receiver regains lock very late, at 412245s.

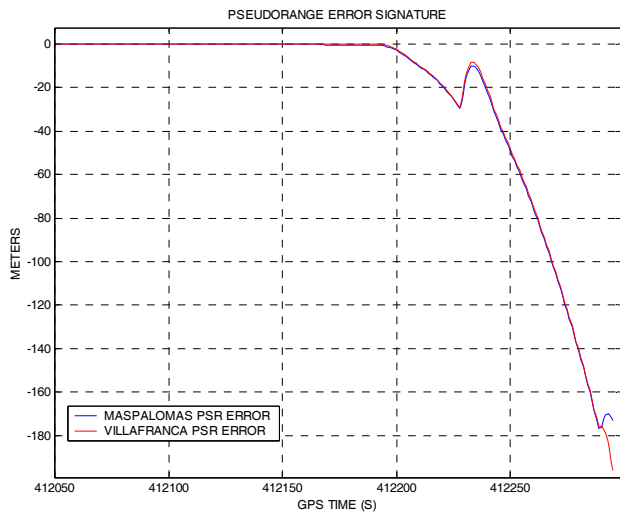
**Figure 8: Pseudorange error signature.**

This figure shows that most of the receivers lose PRN23 at GPS time 412228s (or 412229s depending on the type of receiver) on the first of January 2004. It could explain that the SBAS sent a “Not Monitored” flag instead of a “Don’t Use” one, as the ground station receivers also lost lock. At the beginning of the failure, the slope of the pseudorange error does not explain a loss of tracking. But at 412228s, a real discontinuity in the slope (as shown on the two following figures representing the first and second order derivative) made it very difficult to track PRN23 any longer. Some receivers, as the ones used to characterize this failure, succeeded in tracking PRN23 during this discontinuity. At this moment, we can’t explain why these receivers didn’t lose PRN23.

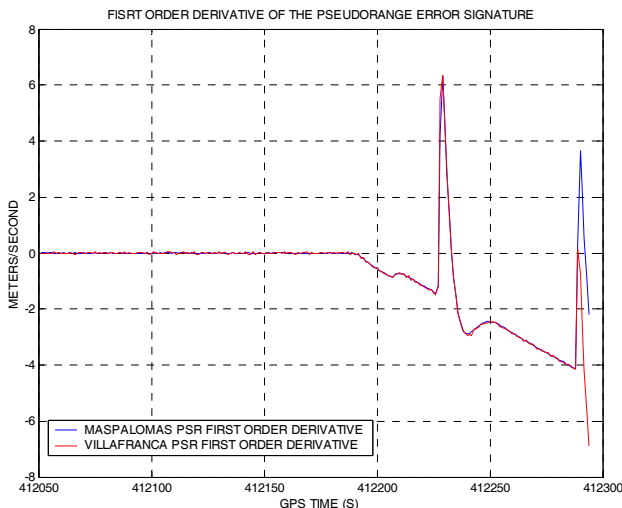
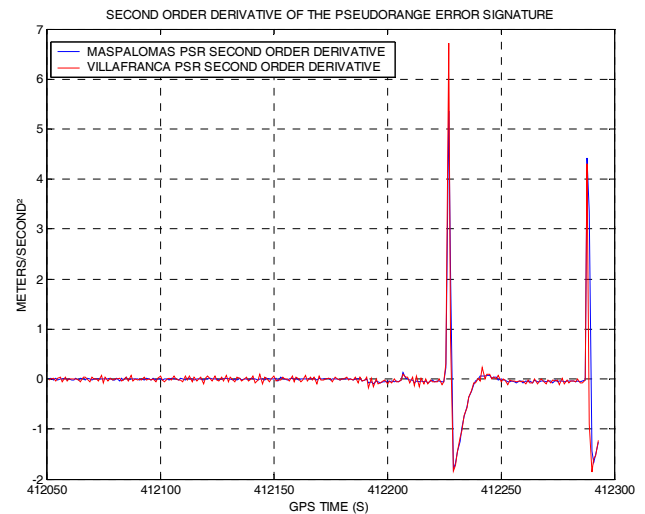
**Figure 9: First order derivative of the pseudorange error signature.**

**Figure 10: Second order derivative of the pseudorange error signature .**

On the previous figures, two impulsions in the slope are visible. But the second one does not present exactly the same shape if we look at data coming from Villafranca or Maspalomas. In fact, the receiver in Maspalomas lost PRN23 tracking just after the second slope discontinuity and the PRN23 pseudorange could therefore have been affected in a different manner. That is why we focused our attention on the first slope discontinuity.

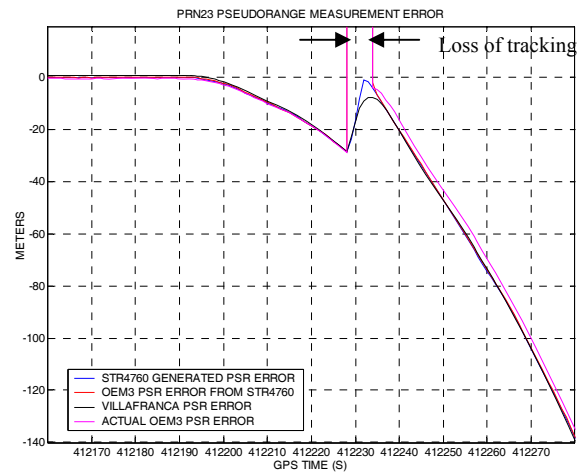
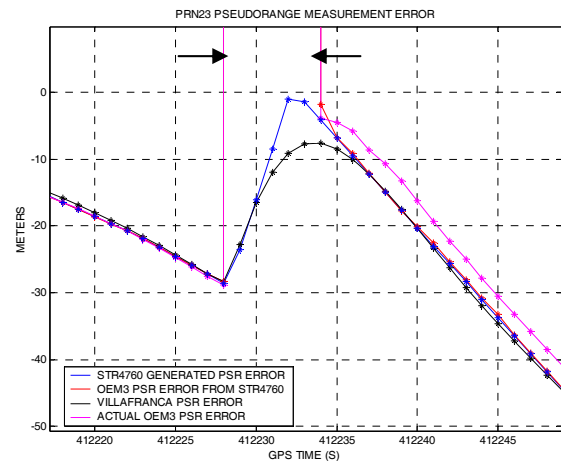
Figure 11: PRN23 pseudorange measurement error.

Figure 12: Zoom on PRN23 pseudorange measurement error.

- A rupture in the slope of the failure is responsible for the loss of tracking of PRN23 for the Novatel OEM3;
- The OEM3 used for the simulation effectively loses PRN23 tracking during 5 seconds before reacquiring it again which is in line with what was observed.
- The magenta curve, representing the actual OEM3 PRN23 pseudorange error, is biased after the break : in fact for these data, the clock bias was not available and the pseudorange is therefore not corrected from that error. The break may have introduced a little jump in the clock bias (about 5 meters certainly coming from a divergence of the internal clock of the receiver) explaining that this curve is not superimposed on the other ones.

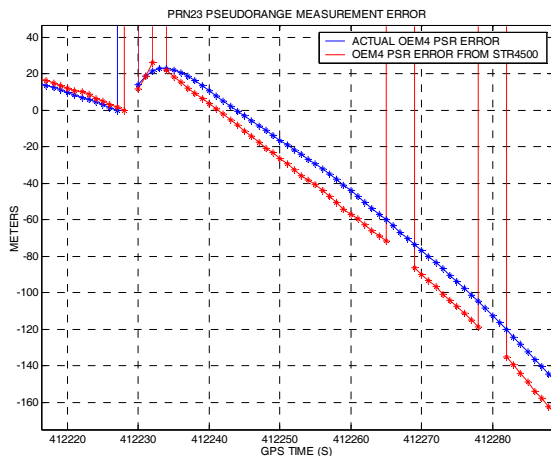
**Figure 13: OEM4 PRN23 pseudorange measurement error.**

Again, the shape of the two curves is very similar. The main differences are due to the fact that :

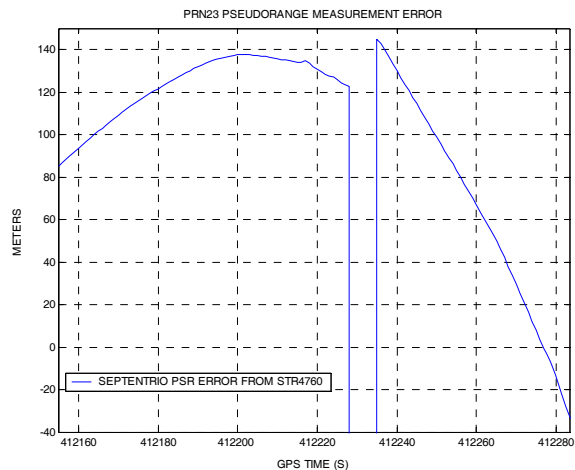
**Figure 14: Septentrio PRN23 pseudorange measurement error.**

The same scenario has been used to observe the behavior of a Septentrio receiver. No real data were available to make a comparison, but with the scenario, the Septentrio also loses the PRN23 at GPS time 412229s during 6 seconds (figure 14). But when plotting the results, the problem of the estimation of the bias was worse than with the Novatel OEM4, and the divergence of the pseudorange was too large to well see the impact of the failure on the following figure.
