Effect of a GPS anomaly on different GNSS receivers

Anne-Laure Vogel, Christophe Macabiau, Norbert Suard

Anne-Laure Vogel, Christophe Macabiau, Norbert Suard. Effect of a GPS anomaly on different GNSS receivers. ION GNSS 2005, 18th International Technical Meeting of the Satellite Division of The Institute of Navigation, Sep 2005, Long Beach, United States. pp 1645-1655, 2005. <hal-01022185>

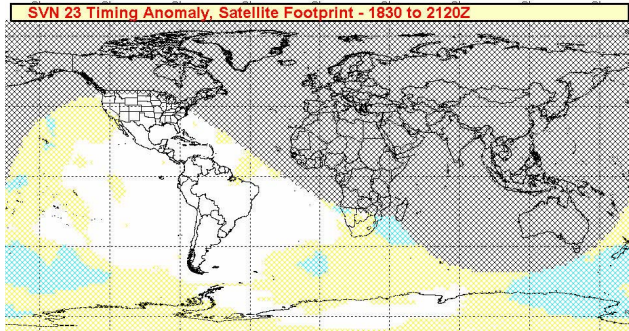
An important anomaly of the GPS system occurred on January 1, 2004, starting at around 18h30 UTC, and affecting time and position estimates on a very wide zone illustrated in figure 1.

Figure 1: Affected area shown in gray [RD1]

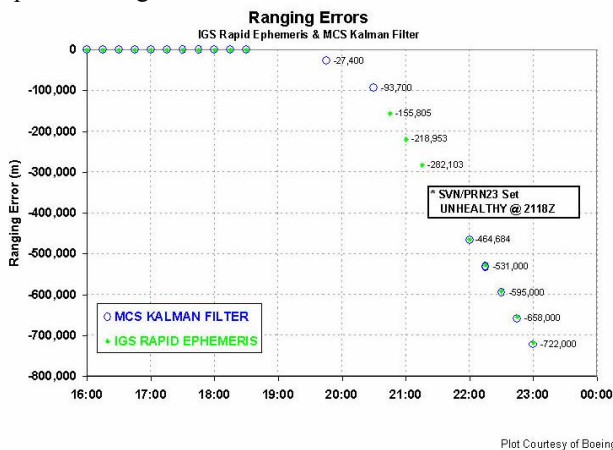
This anomaly was due to a failure of the atomic clock system on the satellite PRN 23. The satellite PRN 23 was declared unusable at 21h18 UTC through transmission of the corresponding SV Unhealthy flag in its navigation message. This failure induced very important errors on the pseudo-range of the satellite 23 as depicted in figure 2.

Figure 2: Pseudo-range error on the PRN 23 [RD1]

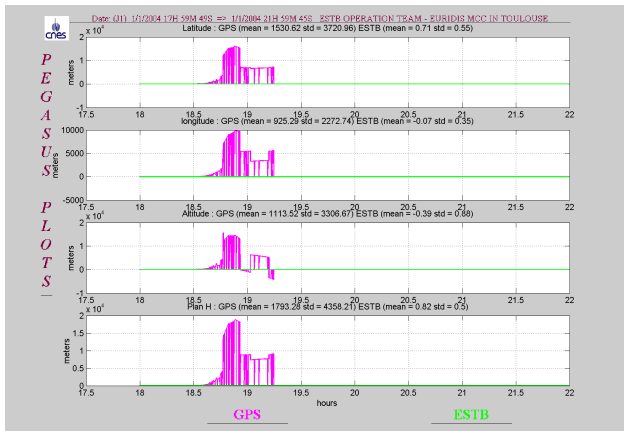
Figure 4: Latitude, Longitude, Altitude and Horizontal errors from 18h00 to 22h00 UTC

In this case, as the receiver of the IGN station continued tracking the satellite 23, we observe positioning errors of several km.

due to the satellite PRN 23 signal being tracked with difficulty by the receiver.

At 19h15min UTC, the receiver of the IGN station stopped to deliver PRN 23 measurements and position estimates became correct again. It is also the same phenomenon that occurred for the majority of the permanent GPS reference stations.

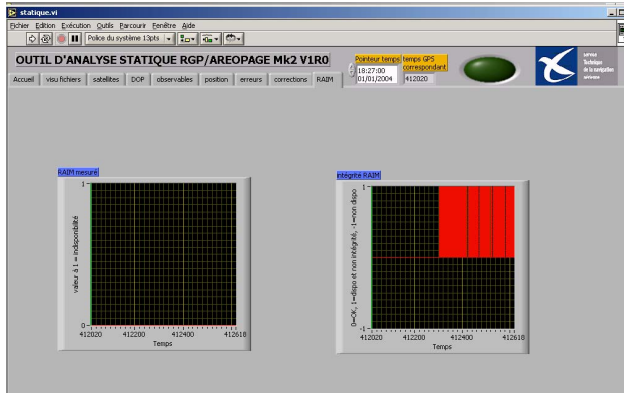
Starting from 18h31min43s (412303s), the flag of RAIM integrity is activated. At this time, the altitude error reached 54 meters and the horizontal error 45 meters (values obtained using the analysis tool).

Figure 5: « RAIM » functionality from 18h27 to 18h37 – GPS time

The RAIM detection criterion which is calculated by AREOPAGE Mk2 and which emulates the RAIM of a standard supplemental TSO C129 receiver, such as necessary for NPA-GPS (LNAV) approaches, detected the failure as soon as the error reached a too large value, 110 seconds after the beginning of the failure in that case.

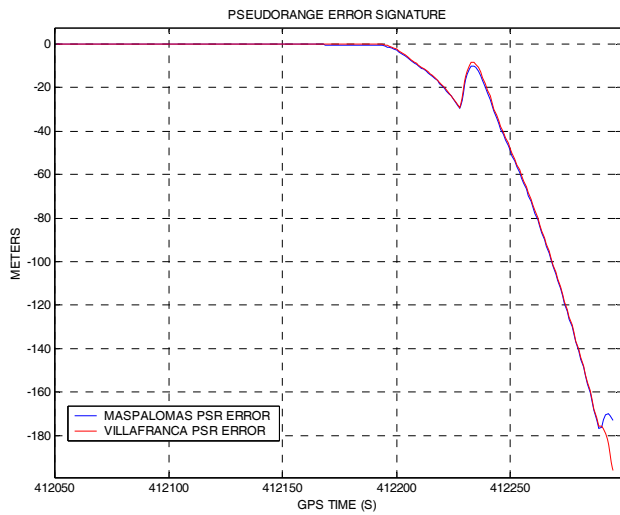
Figure 8: Pseudorange error signature.

This figure shows that most of the receivers lose PRN23 at GPS time 412228s (or 412229s depending on the type of receiver) on the first of January 2004. It could explain that the SBAS sent a “Not Monitored” flag instead of a “Don’t Use” one, as the ground station receivers also lost lock. At the beginning of the failure, the slope of the pseudorange error does not explain a loss of tracking. But at 412228s, a real discontinuity in the slope (as shown on the two following figures representing the first and second order derivative) made it very difficult to track PRN23 any longer. Some receivers, as the ones used to characterize this failure, succeeded in tracking PRN23 during this discontinuity. At this moment, we can’t explain why these receivers didn’t lose PRN23.

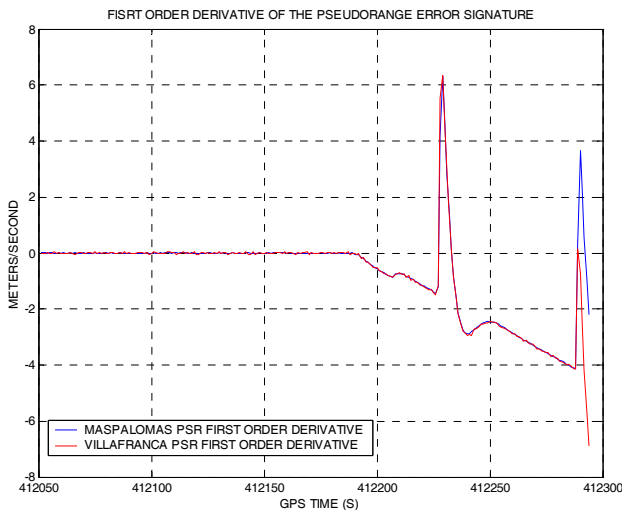
Figure 9: First order derivative of the pseudorange error signature.

On the previous figures, two impulsions in the slope are visible. But the second one does not present exactly the same shape if we look at data coming from Villafranca or Maspalomas. In fact, the receiver in Maspalomas lost PRN23 tracking just after the second slope discontinuity and the PRN23 pseudorange could therefore have been affected in a different manner. That is why we focused our attention on the first slope discontinuity.

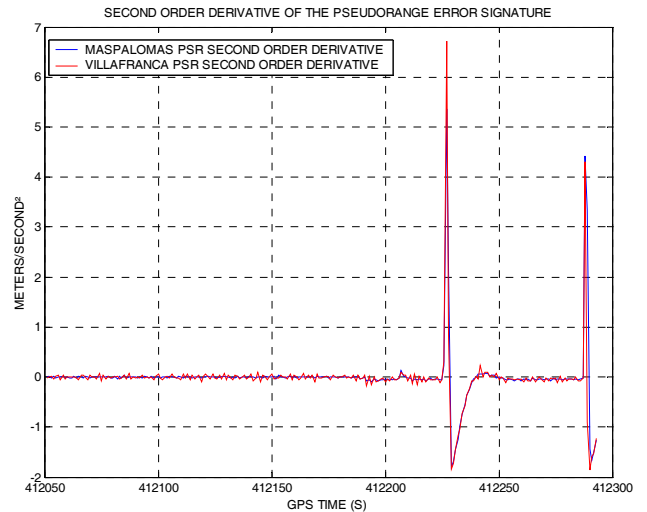
Figure 10: Second order derivative of the pseudorange error signature .

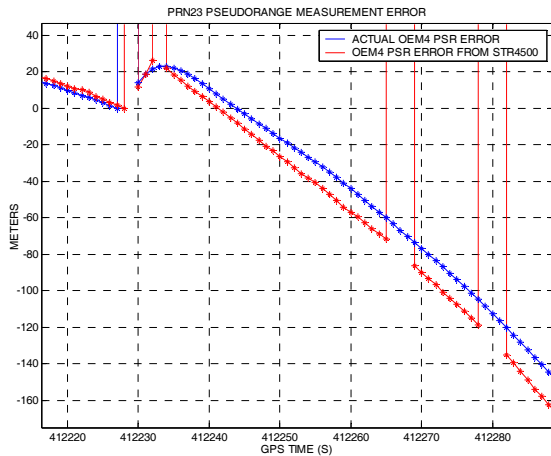
Figure 13: OEM4 PRN23 pseudorange measurement error.

Again, the shape of the two curves is very similar. The main differences are due to the fact that :

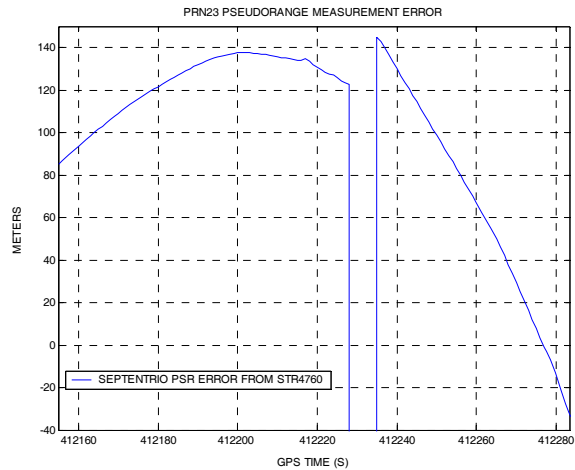
The same scenario has been used to observe the behavior of a Septentrio receiver. No real data were available to make a comparison, but with the scenario, the Septentrio also loses the PRN23 at GPS time 412229s during 6 seconds (figure 14). But when plotting the results, the problem of the estimation of the bias was worse than with the Novatel OEM4, and the divergence of the pseudorange was too large to well see the impact of the failure on the following figure.

Figure 14: Septentrio PRN23 pseudorange measurement error.
