Effect of a GPS Anomaly on Different GNSS Receivers

Anne-Laure Vogel, *Sofréavia, France*
Christophe Macabiau, *ENAC, France*
Norbert Suard, *CNES, France*

On January 1st 2004, a GPS clock failure occurred suddenly onboard the GPS satellite PRN23 at around 18:30 UTC with the signal being transmitted for hours after that. The Unhealthy flag of its navigation message, used by the receivers to discard its measurements from the navigation position computation, was raised a few hours after the occurrence of this event.

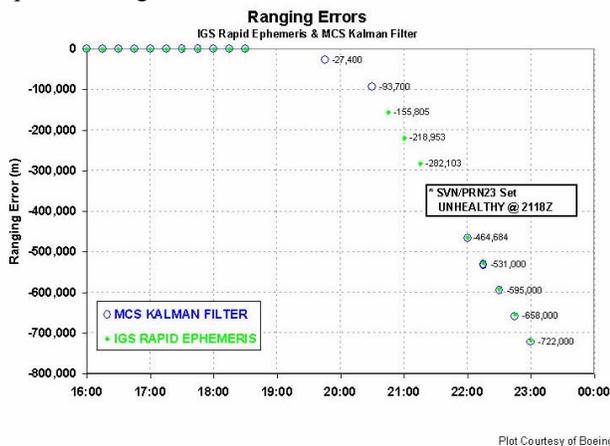
Figure 2: Pseudo-range error on the PRN 23 [RD1]

This anomaly was due to a failure of the atomic clock system on the satellite PRN 23. The satellite PRN 23 was declared unusable at 21h18 UTC through transmission of the corresponding SV Unhealthy flag in its navigation message. This failure induced very important errors on the pseudo-range of the satellite 23 as depicted in figure 2.

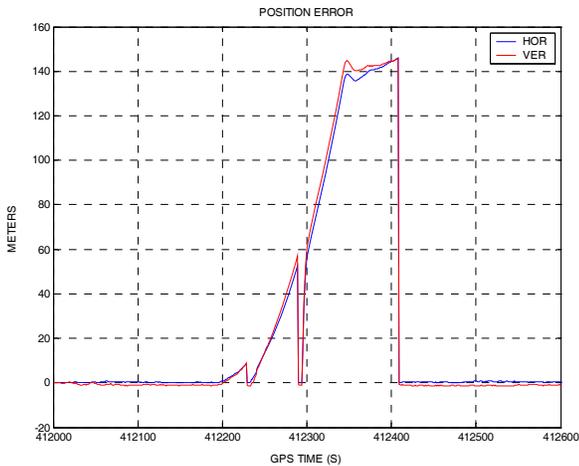
Figure 3: Horizontal and vertical position error from 18h26min40s to 18h36min40s (GPS time)

Starting from 18h29min53s (that is to say 412193 sec. in GPS time), we note that the horizontal and vertical position errors increase quickly to 150m as shown on figure 3. These values are in conformity with those observed by CNES [RD 3].

Approximately 200 seconds after the appearance of the incident (GPS time 412409s), the receiver provides positions with horizontal and vertical errors becoming again normal. It seems that the receiver fails to track the satellite 23.

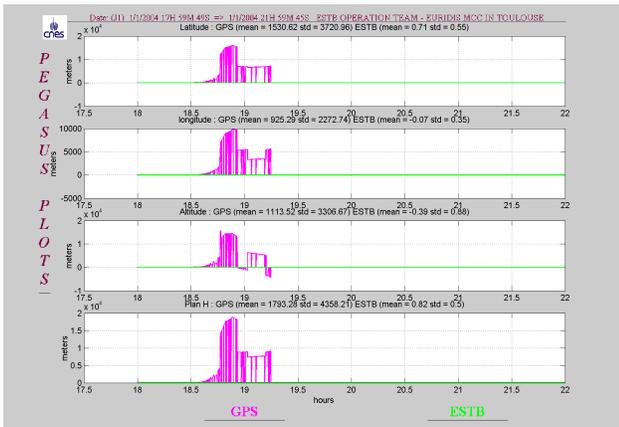
Figure 4: Latitude, Longitude, Altitude and Horizontal errors from 18h00 to 22h00 UTC

In this case, as the receiver of the IGN station continued tracking the satellite 23, we observe positioning errors of several km.

due to the satellite PRN 23 signal being tracked with difficulty by the receiver.

At 19h15min UTC, the receiver of the IGN station stopped to deliver PRN 23 measurements and position estimates became correct again. It is also the same phenomenon that occurred for the majority of the permanent GPS reference stations.

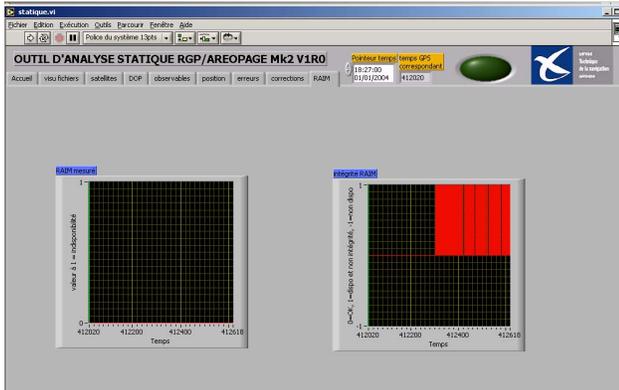
Figure 5: « RAIM » functionality from 18h27 to 18h37 – GPS time

Starting from 18h31min43s (412303s), the flag of RAIM integrity is activated. At this time, the altitude error reached 54 meters and the horizontal error 45 meters (values obtained using the analysis tool).

The RAIM detection criterion which is calculated by AREOPAGE Mk2 and which emulates the RAIM of a standard supplemental TSO C129 receiver, such as necessary for NPA-GPS (LNAV) approaches, detected the failure as soon as the error reached a too large value, 110 seconds after the beginning of the failure in that case.

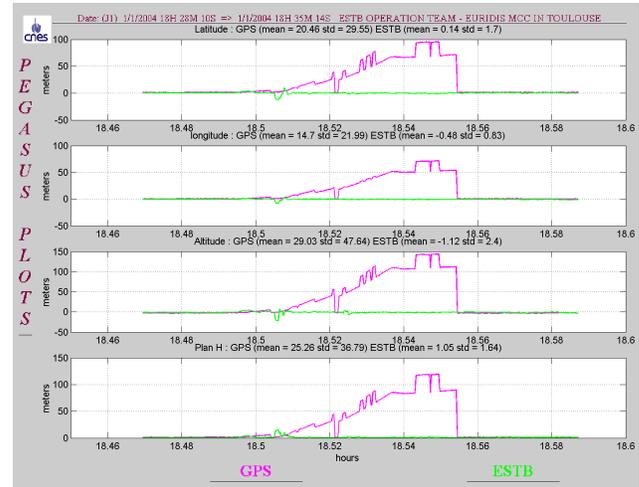
Figure 6: Positions errors (Lat, Lon, V, H) observed with ESTB (green) and GPS only (magenta) functions.

The receivers using ESTB also underwent drifts of position when the failure appeared. These errors reached a maximum of 15m in horizontal and 25m in vertical and only lasted less than 5 seconds, then the PRN23 was excluded in the internal ESTB time reference. These errors are definitely lower than those of standalone GPS receivers. Moreover, the satellite PRN23 was excluded by the ESTB system at 412228s (35 seconds after beginning of the failure).

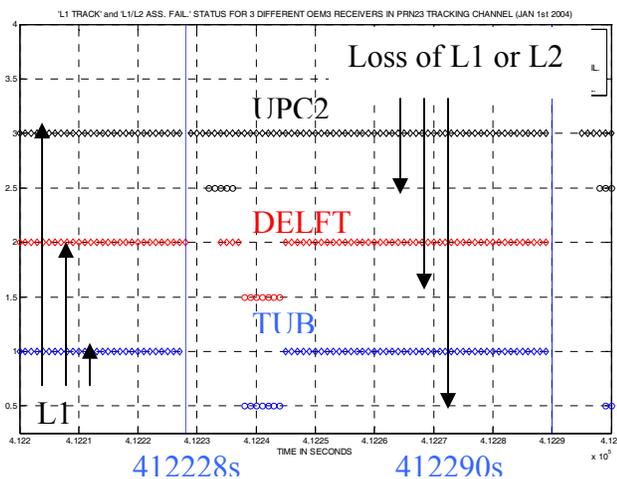
Figure 7: PRN23 tracking status for 3 different OEM3 receivers (TUB, DELFT, UPC2).

As we can see in this figure, TUB and UPC2 receivers lose lock at the exact same time, which is 412228s. DELFT receiver loses lock one second later, at 412229s. Then, UPC2 receiver re-locks on the signal the second after. DELFT receiver regains lock 5 seconds later at 412234s, to lose lock again at 412238s for 6 seconds. TUB receiver regains lock very late, at 412245s.

Then later, at 412290s, all three receivers lose lock at the exact same time.

It is also interesting to note again the wide variety of behaviors of the different receivers after their loss of lock, although they were all OEM3 receivers. This can be explained by different firmware versions being run by the receivers themselves, as well as by different environmental conditions for these receivers, like noise and multipath effect at that time, but also like the number of satellites being tracked by the receiver at that time.

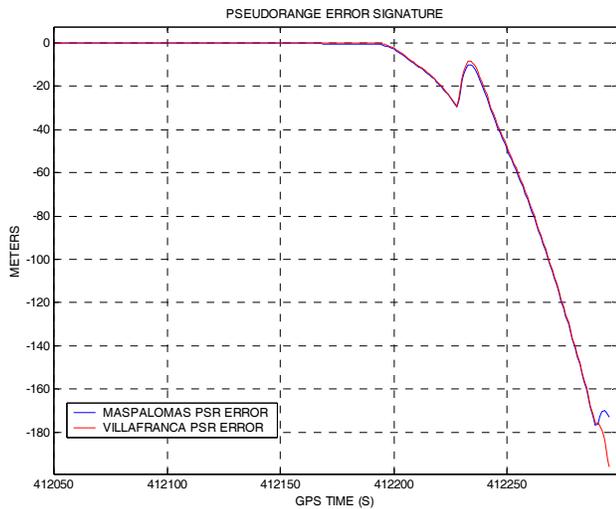
Figure 8: Pseudorange error signature.

This figure shows that most of the receivers lose PRN23 at GPS time 412228s (or 412229s depending on the type of receiver) on the first of January 2004. It could explain that the SBAS sent a “Not Monitored” flag instead of a “Don’t Use” one, as the ground station receivers also lost lock. At the beginning of the failure, the slope of the pseudorange error does not explain a loss of tracking. But at 412228s, a real discontinuity in the slope (as shown on the two following figures representing the first and second order derivative) made it very difficult to track PRN23 any longer. Some receivers, as the ones used to characterize this failure, succeeded in tracking PRN23 during this discontinuity. At this moment, we can’t explain why these receivers didn’t lose PRN23.

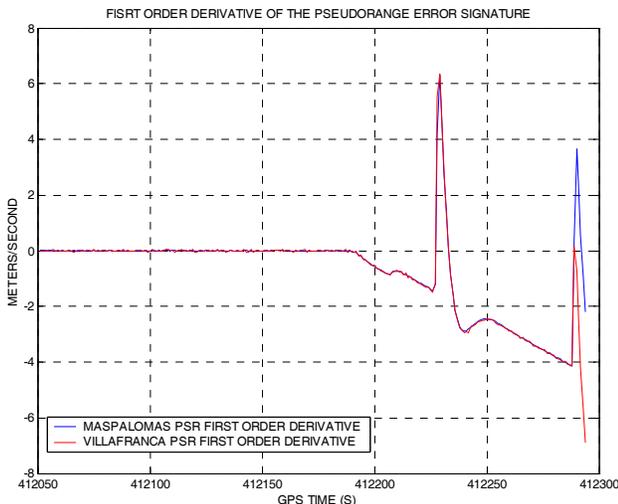
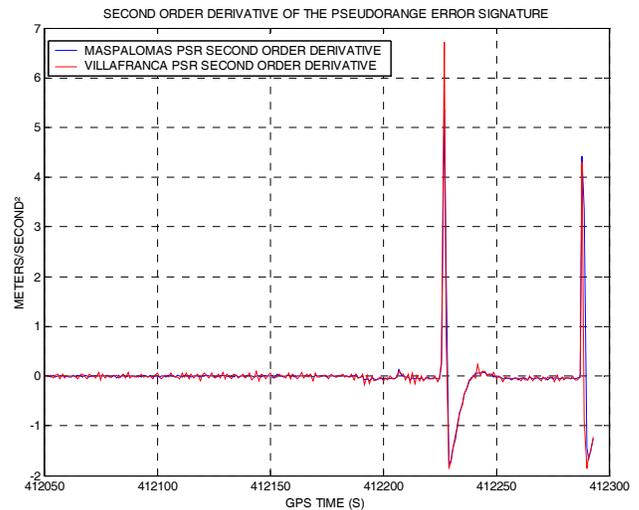
On the previous figures, two impulsions in the slope are visible. But the second one does not present exactly the same shape if we look at data coming from Villafranca or Maspalomas. In fact, the receiver in Maspalomas lost PRN23 tracking just after the second slope discontinuity and the PRN23 pseudorange could therefore have been affected in a different manner. That is why we focused our attention on the first slope discontinuity.

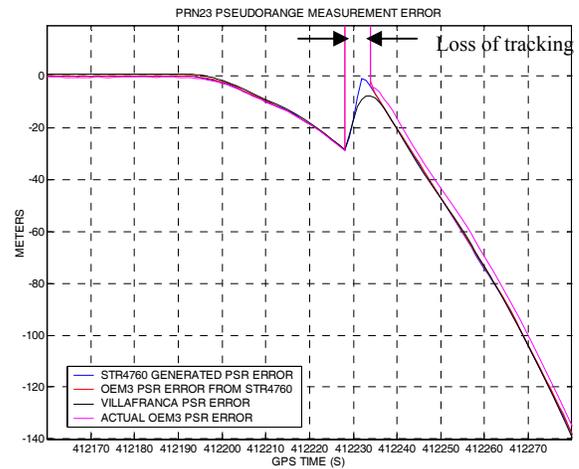
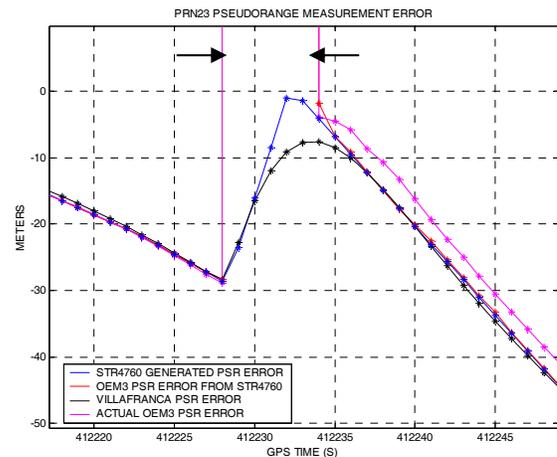
Figure 12: Zoom on PRN23 pseudorange measurement error.

- A rupture in the slope of the failure is responsible for the loss of tracking of PRN23 for the Novatel OEM3;
- The OEM3 used for the simulation effectively loses PRN23 tracking during 5 seconds before reacquiring it again which is in line with what was observed.
- The magenta curve, representing the actual OEM3 PRN23 pseudorange error, is biased after the break : in fact for these data, the clock bias was not available and the pseudorange is therefore not corrected from that error. The break may have introduced a little jump in the clock bias (about 5 meters certainly coming from a divergence of the internal clock of the receiver) explaining that this curve is not superimposed on the other ones.

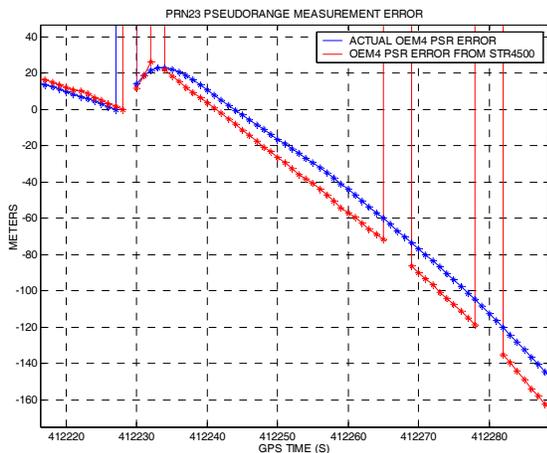
Figure 13: OEM4 PRN23 pseudorange measurement error.

Again, the shape of the two curves is very similar. The main differences are due to the fact that :

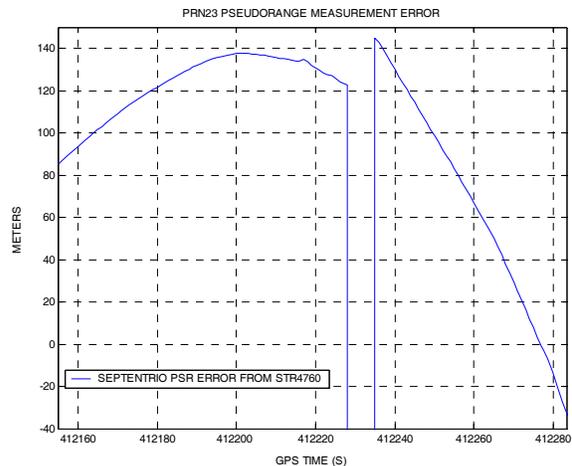
Figure 14: Septentrio PRN23 pseudorange measurement error.

The same scenario has been used to observe the behavior of a Septentrio receiver. No real data were available to make a comparison, but with the scenario, the Septentrio also loses the PRN23 at GPS time 412229s during 6 seconds (figure 14). But when plotting the results, the problem of the estimation of the bias was worse than with the Novatel OEM4, and the divergence of the pseudorange was too large to well see the impact of the failure on the following figure.
