Effect of a GPS anomaly on different GNSS receivers

Anne-Laure Vogel, Christophe Macabiau, Norbert Suard

Anne-Laure Vogel, Christophe Macabiau, Norbert Suard. Effect of a GPS anomaly on different GNSS receivers. ION GNSS 2005, 18th International Technical Meeting of the Satellite Division of The Institute of Navigation, Sep 2005, Long Beach, United States. pp 1645-1655, 2005. <hal-01022185>

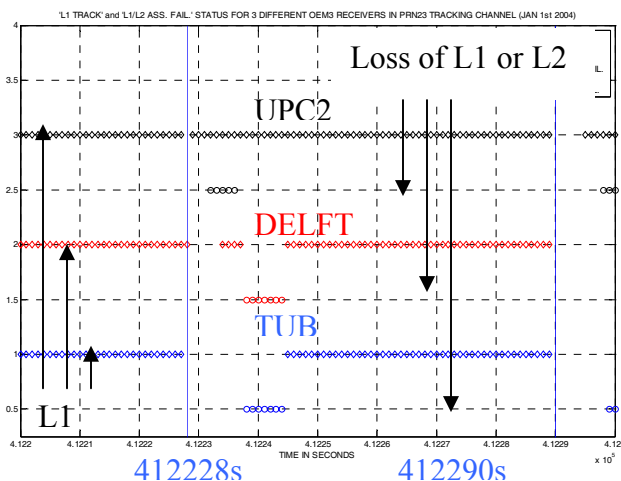
Figure 7: PRN23 tracking status for 3 different OEM3 receivers (TUB, DELFT, UPC2).

As we can see in this figure, TUB and UPC2 receivers lose lock at the exact same time, which is 412228s. DELFT receiver loses lock one second later, at 412229s. Then, UPC2 receiver re-locks on the signal the second after. DELFT receiver regains lock 5 seconds later at 412234s, to lose lock again at 412238s for 6 seconds. TUB receiver regains lock very late, at 412245s.

Then later, at 412290s, all three receivers lose lock at the exact same time.
