Effect of a GPS anomaly on different GNSS receivers

Anne-Laure Vogel, Christophe Macabiau, Norbert Suard

Anne-Laure Vogel, Christophe Macabiau, Norbert Suard. Effect of a GPS anomaly on different GNSS receivers. ION GNSS 2005, 18th International Technical Meeting of the Satellite Division of The Institute of Navigation, Sep 2005, Long Beach, United States. pp 1645-1655, 2005. <hal-01022185>

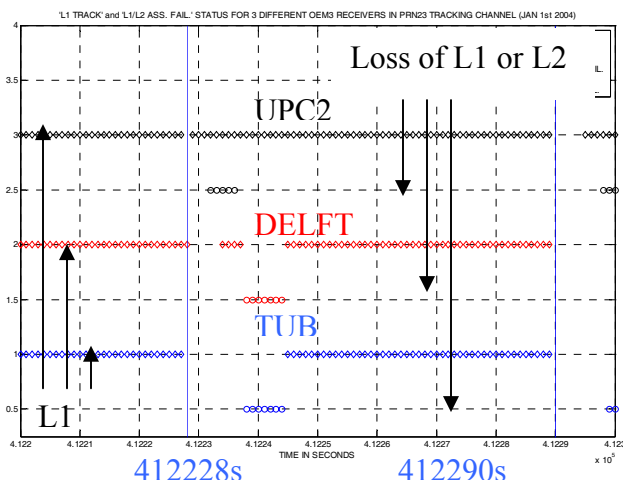
Figure 7: PRN23 tracking status for 3 different OEM3 receivers (TUB, DELFT, UPC2).

As we can see in this figure, TUB and UPC2 receivers lose lock at the exact same time, which is 412228s. DELFT receiver loses lock one second later, at 412229s. Then, UPC2 receiver re-locks on the signal the second after. DELFT receiver regains lock 5 seconds later at 412234s, to lose lock again at 412238s for 6 seconds. TUB receiver regains lock very late, at 412245s.

Then later, at 412290s, all three receivers lose lock at the exact same time.

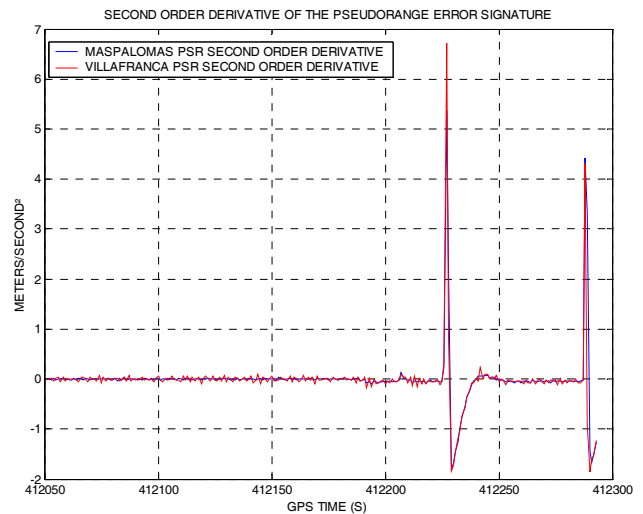
Figure 10: Second order derivative of the pseudorange error signature .

On the previous figures, two impulsions in the slope are visible. But the second one does not present exactly the same shape if we look at data coming from Villafranca or Maspalomas. In fact, the receiver in Maspalomas lost PRN23 tracking just after the second slope discontinuity and the PRN23 pseudorange could therefore have been affected in a different manner. That is why we focused our attention on the first slope discontinuity.
