# Effect of a GPS Anomaly on Different GNSS Receivers

Anne-Laure Vogel, *Sofréavia, France*  
Christophe Macabiau, *ENAC, France*  
Norbert Suard, *CNES, France*

On January 1<sup>st</sup> 2004, a GPS clock failure occurred suddenly onboard the GPS satellite PRN23 at around 18:30 UTC with the signal being transmitted for hours after that. The Unhealthy flag of its navigation message, used by the receivers to discard its measurements from the navigation position computation, was raised a few hours after the occurrence of this event.

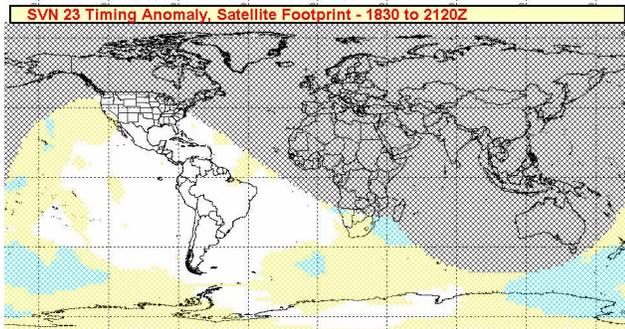
An important anomaly of the GPS system occurred on January 1, 2004, starting at around 18h30 UTC, and affecting time and position estimates on a very wide zone illustrated in figure 1.

Figure 1: Affected area shown in gray [RD1]

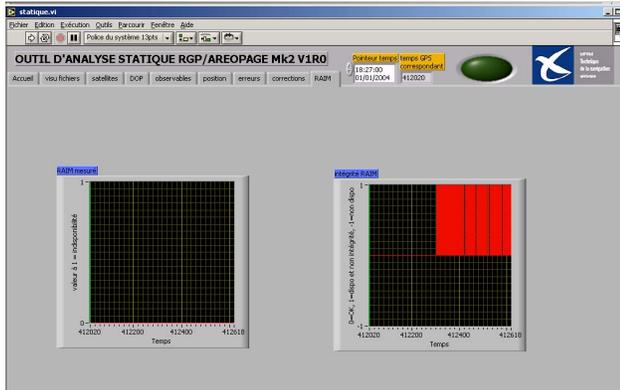
Starting from 18h31min43s (412303s), the flag of RAIM integrity is activated. At this time, the altitude error reached 54 meters and the horizontal error 45 meters (values obtained using the analysis tool).

Figure 5: « RAIM » functionality from 18h27 to 18h37 – GPS time

The RAIM detection criterion which is calculated by AREOPAGE Mk2 and which emulates the RAIM of a standard supplemental TSO C129 receiver, such as necessary for NPA-GPS (LNAV) approaches, detected the failure as soon as the error reached a too large value, 110 seconds after the beginning of the failure in that case.
