Effect of a GPS anomaly on different GNSS receivers

Anne-Laure Vogel, Christophe Macabiau, Norbert Suard

Anne-Laure Vogel, Christophe Macabiau, Norbert Suard. Effect of a GPS anomaly on different GNSS receivers. ION GNSS 2005, 18th International Technical Meeting of the Satellite Division of The Institute of Navigation, Sep 2005, Long Beach, United States. pp 1645-1655. hal-01022185

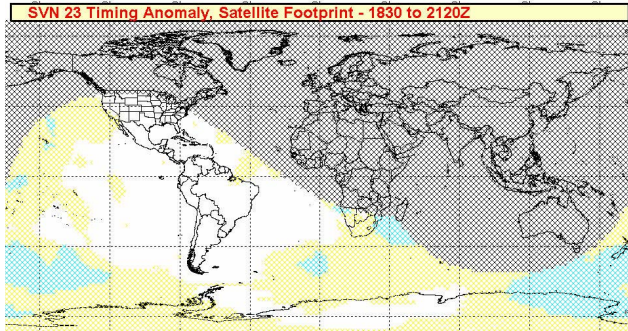
An important anomaly of the GPS system occurred on January 1, 2004, starting at around 18h30 UTC, and affecting time and position estimates on a very wide zone illustrated in figure 1.

Figure 1: Affected area shown in gray [RD1]

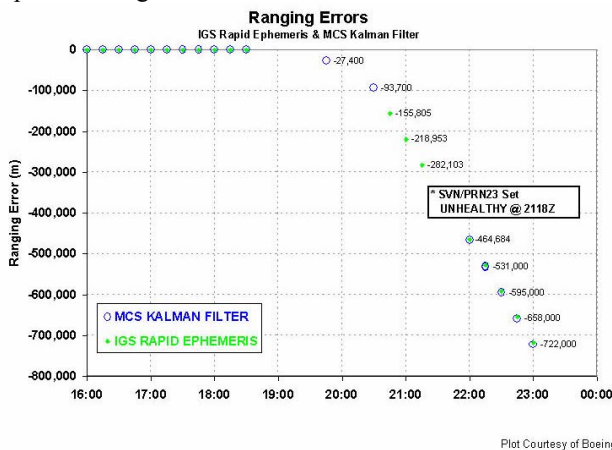
This anomaly was due to a failure of the atomic clock system on the satellite PRN 23. The satellite PRN 23 was declared unusable at 21h18 UTC through transmission of the corresponding SV Unhealthy flag in its navigation message. This failure induced very important errors on the pseudo-range of the satellite 23 as depicted in figure 2.

Figure 2: Pseudo-range error on the PRN 23 [RD1]
